SITE VISIT
RICO-ARGENTINE MINE
RICO, COLORADO
TDD #R8-8408-17

EPA REGIONAL SITE PROJECT OFFICER: THOMAS STAIBLE
FIT PROJECT OFFICER: MARGARET BABITS

SUBMITTED TO: KEITH SCHWAB - FIT RPO
DATE SUBMITTED: OCTOBER 18, 1984

SITE VISIT
AT THE
ANACONDA MINERALS COMPANY
RICO - ARGENTINE MINE
TDD #R8-8408-17

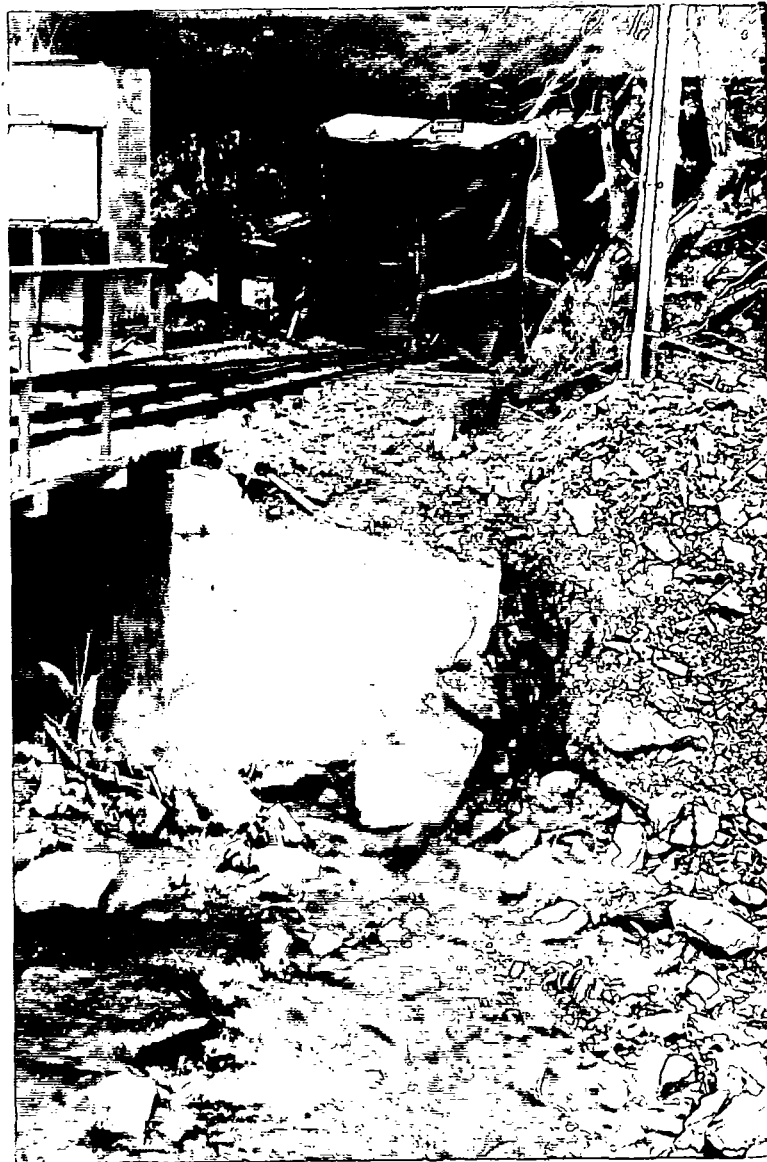
PHOTO 1: SILVER CREEK IN FOREGROUND AND BLAINE TUNNEL IN BACKGROUND. NOTE DISCHARGE FROM BLAINE TUNNEL INTO SILVER CREEK.

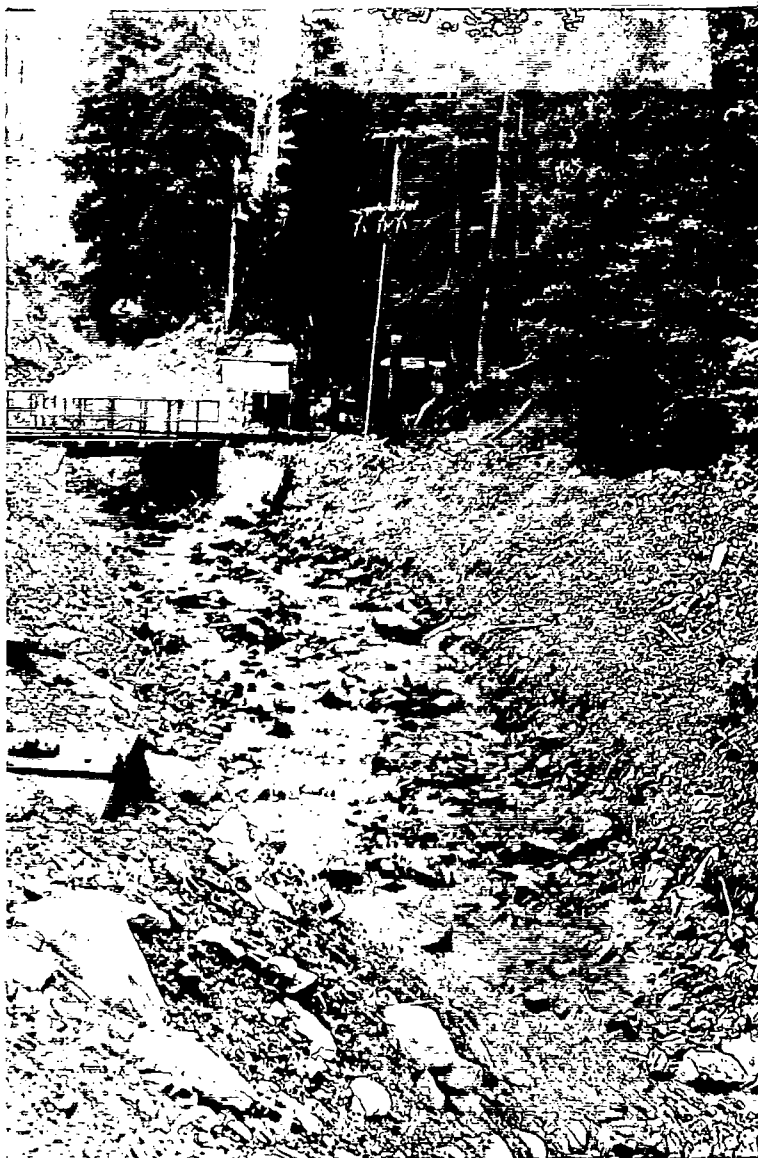
PHOTO 3: SILVER CREEK BELOW BLAINE TUNNEL.
NOTE IRON STAINING ON ROCKS.

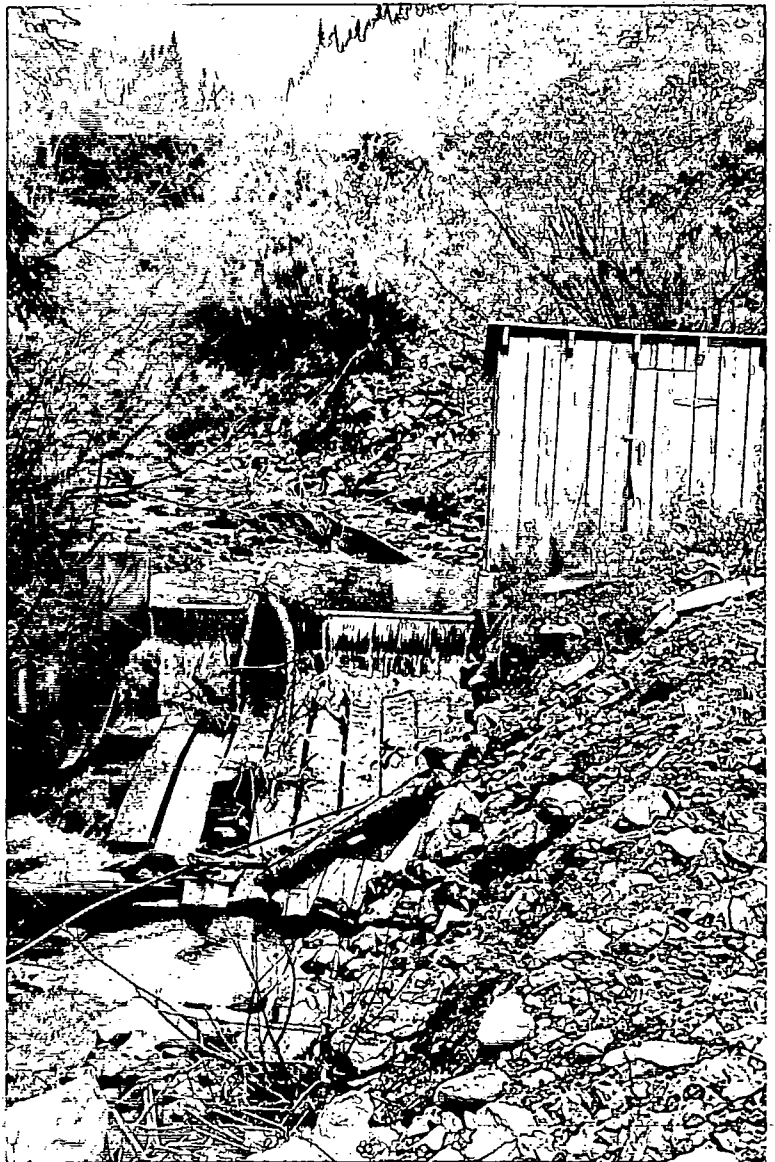
PHOTO 4: (RIGHT) LOCATION OF THE TOWN OF RICO'S DRINKING WATER SUPPLY FROM SILVER CREEK ABOVE BLAINE TUNNEL AND ABOVE MOST MINING ACTIVITY.

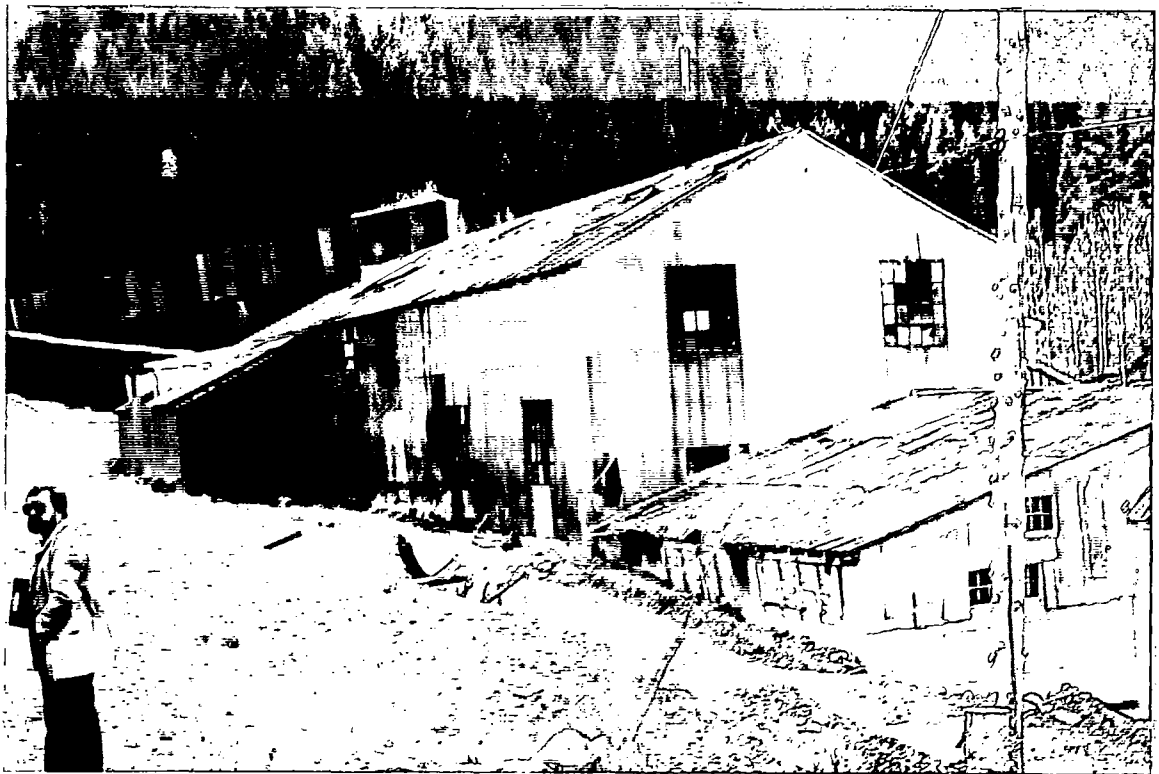
PHOTO 6: THE INACTIVE RICO-ARGENTINE MILL IN THE SILVER CREEK AREA.

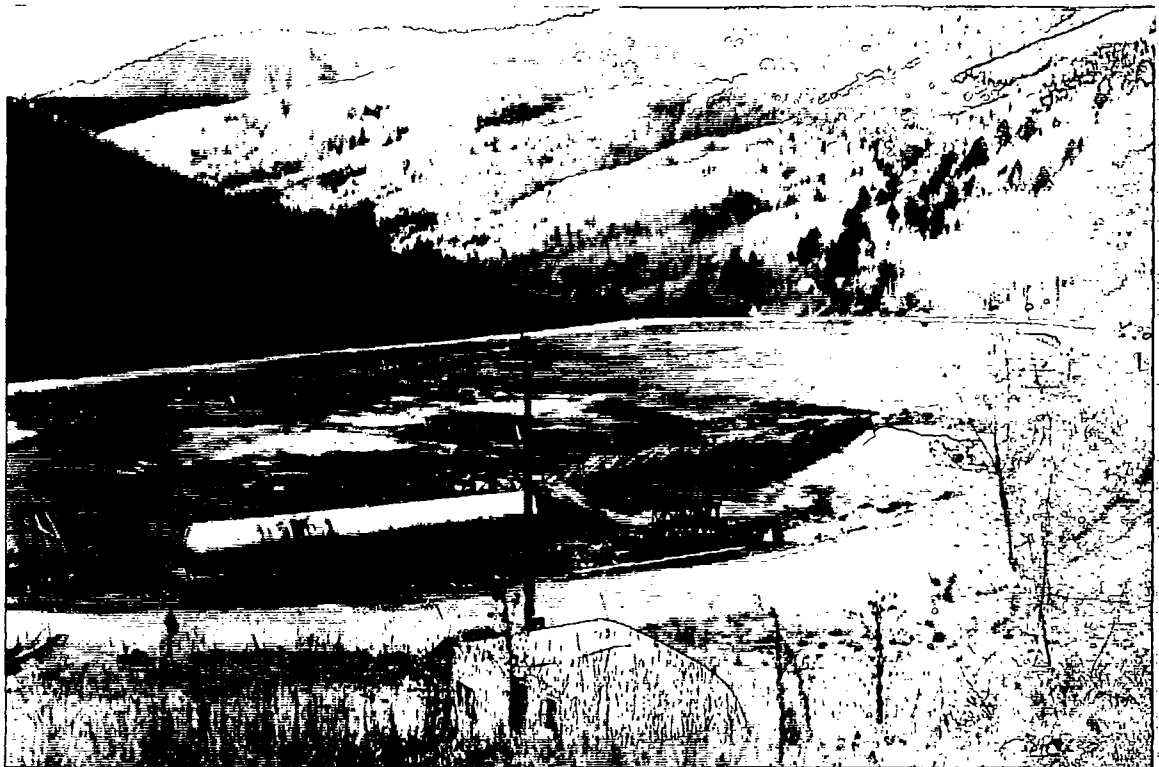
PHOTO 7: VIEW OF RICO-ARGENTINE'S UPPER TAILINGS PONDS LOOKING FROM THE MILL.

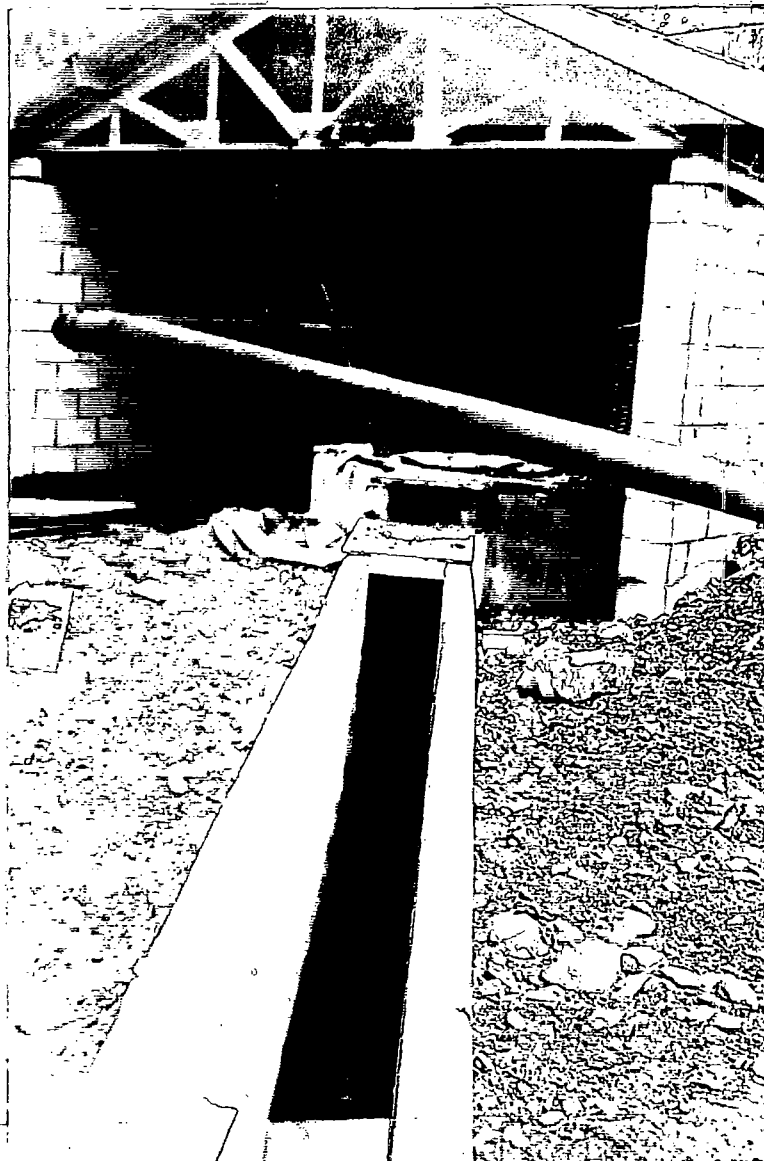
PHOTO 11: (RIGHT) THE ST. LOUIS
ADDIT WHICH RECEIVES
DISCHARGE FROM BLAINE
TUNNEL THROUGH THE
UNDERGROUND ST. LOUIS
TUNNEL SYSTEM. THE
ADDIT IS IN THE
DOLORES RIVER AREA.

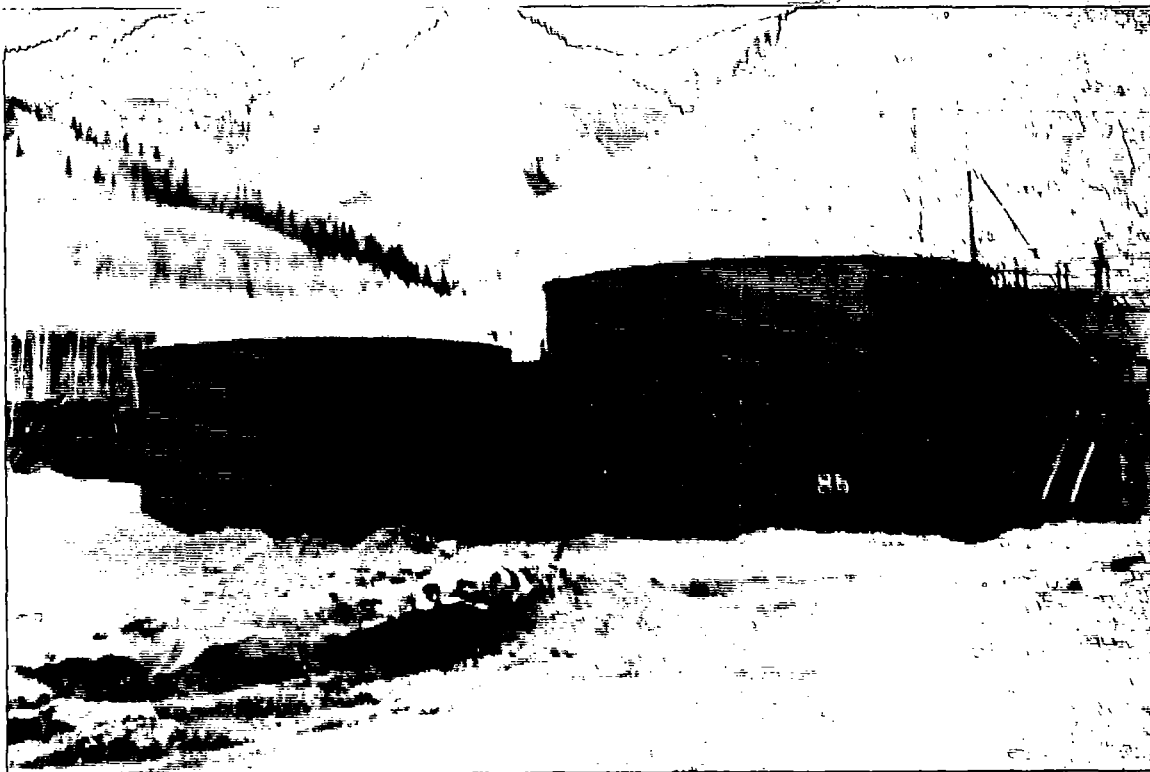
PHOTO 13: STORAGE TANKS FOR INACTIVE SULFURIC ACID PLANT IN DOLORES RIVER AREA.

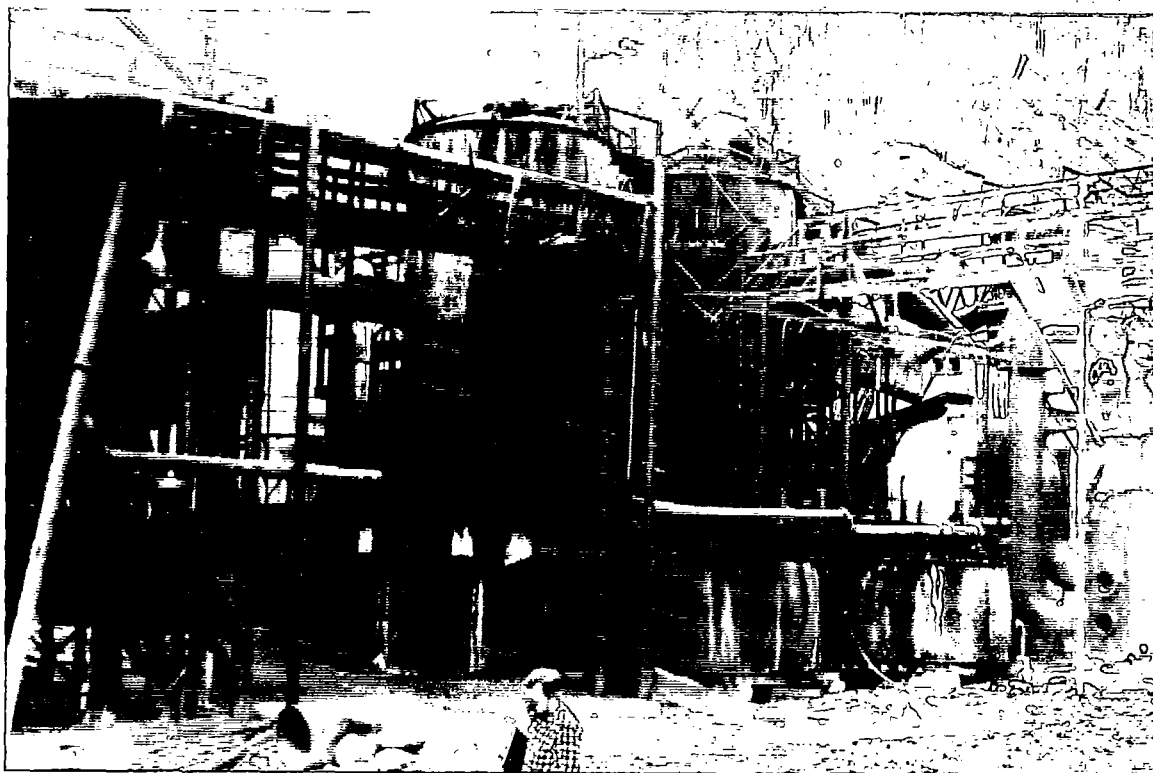
PHOTO 14: THE INACTIVE SULFURIC ACID PLANT. NOTE NUMEROUS DEAD TREES IN BACKGROUND.

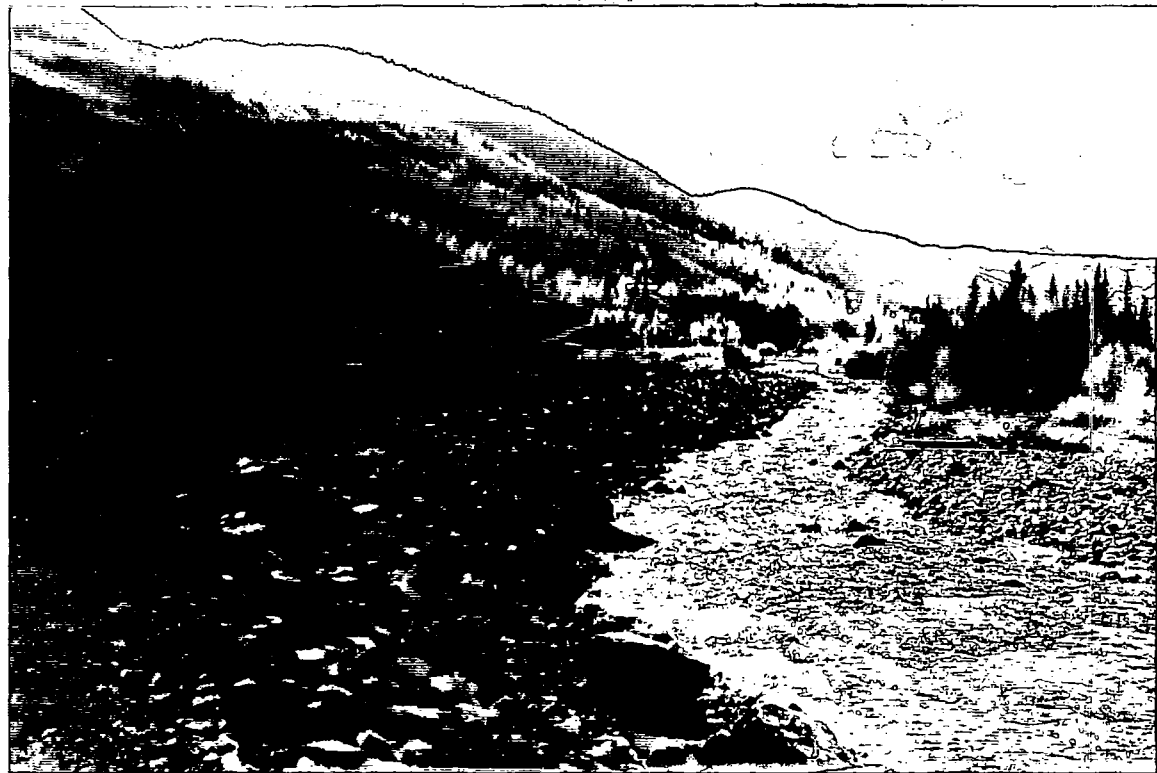
PHOTO 17: (ABOVE) BANK
STABILIZATION ON
DOLORRES RIVER OPPOSITE
LOWER SETTLING PONDS.
